Technology Report 77-2

THE BROWNS FERRY NUCLEAR PLANT FIRE

ANDREW J. PRYOR
U.S. Energy Research
and Development Administration
Albuquerque, New Mexico

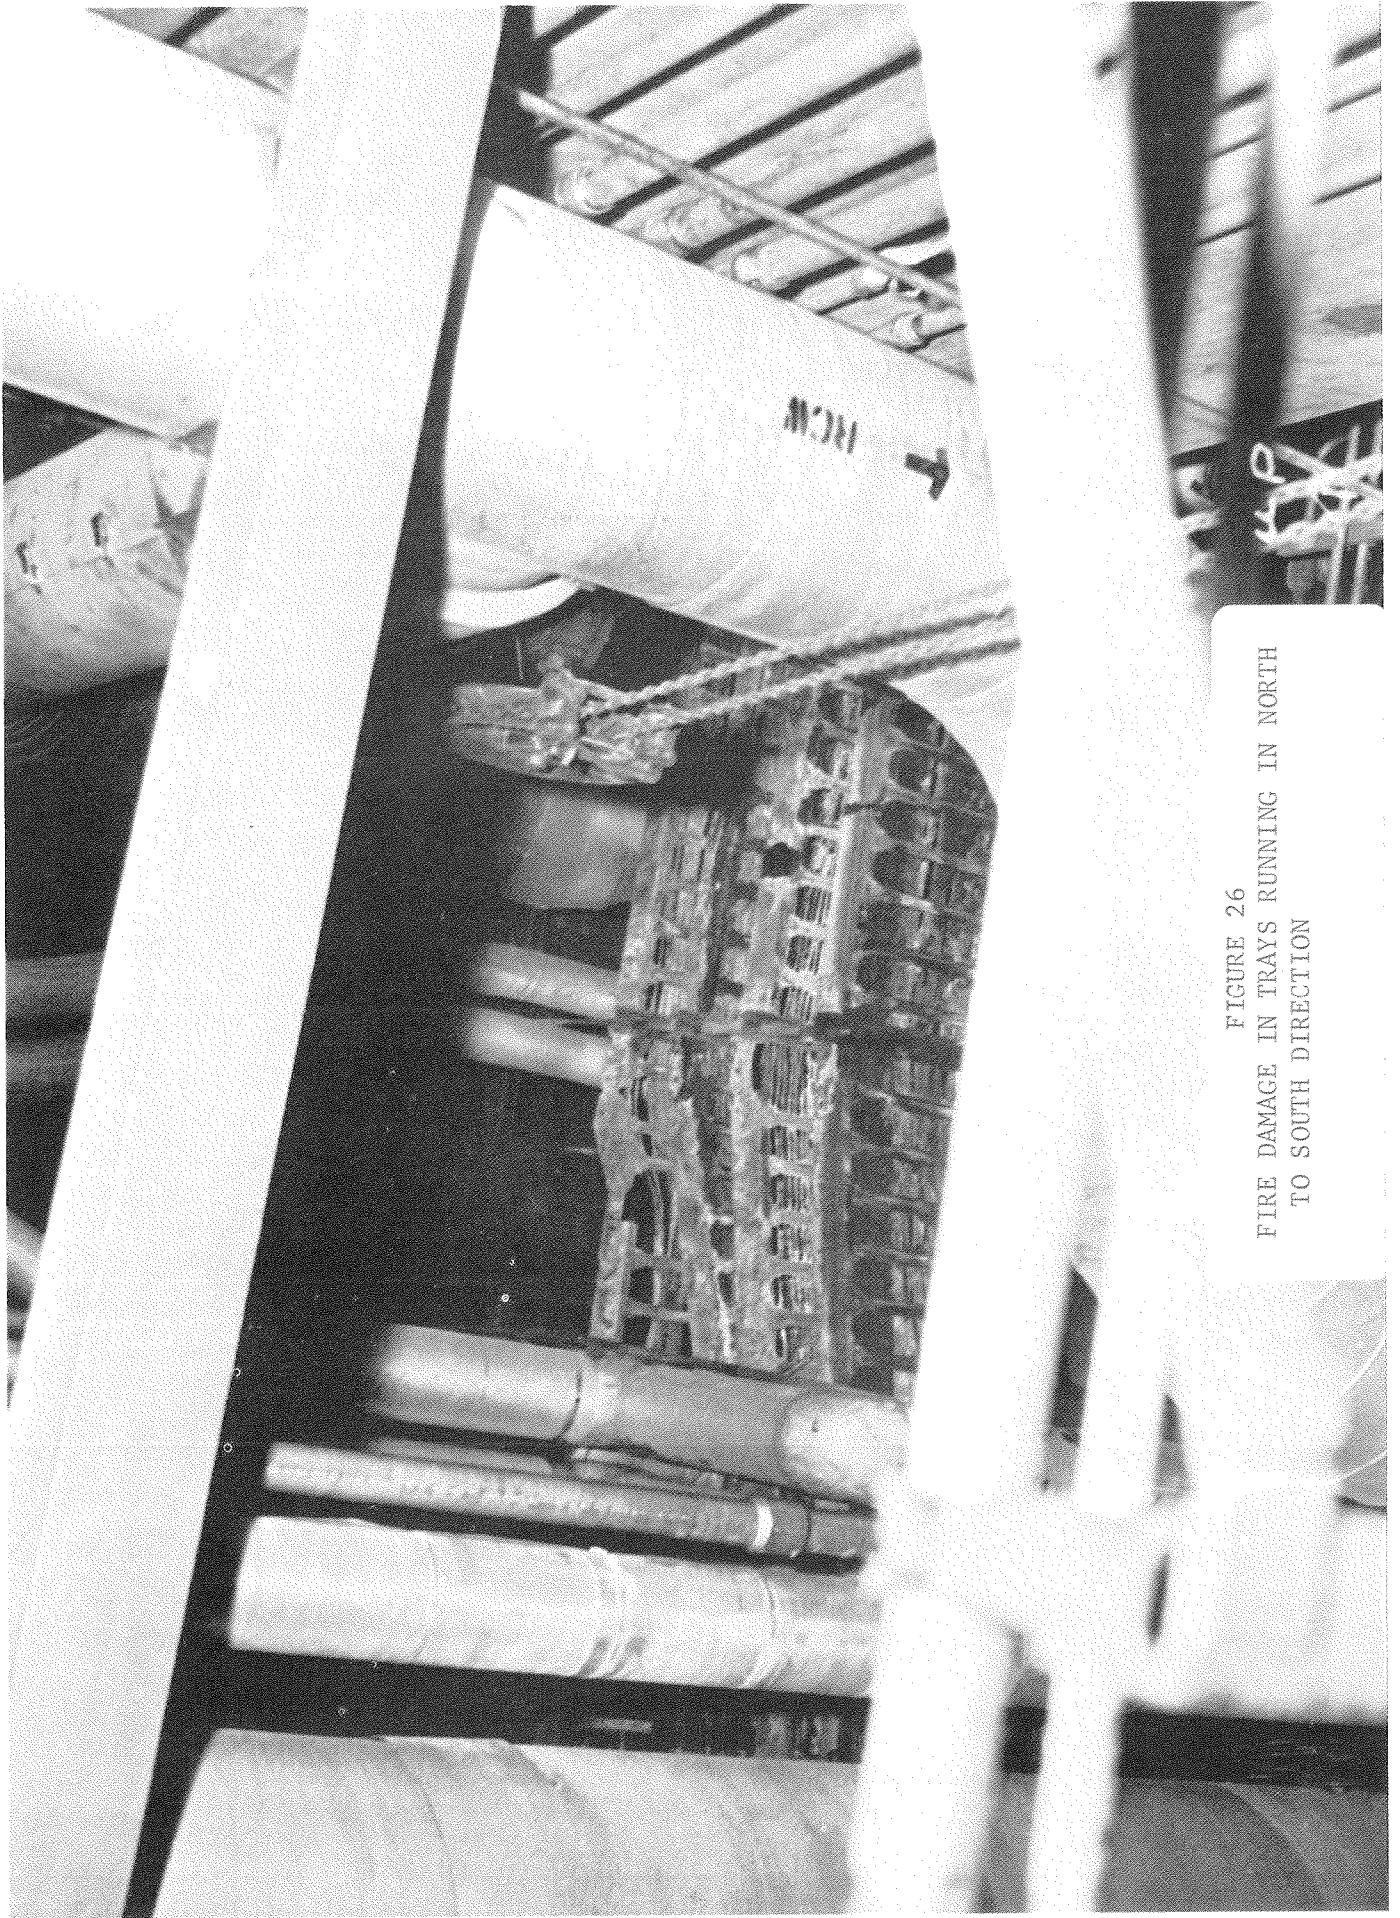
FIGURE 26
FIRE DAMAGE IN TRAYS RUNNING IN NORTH
TO SOUTH DIRECTION

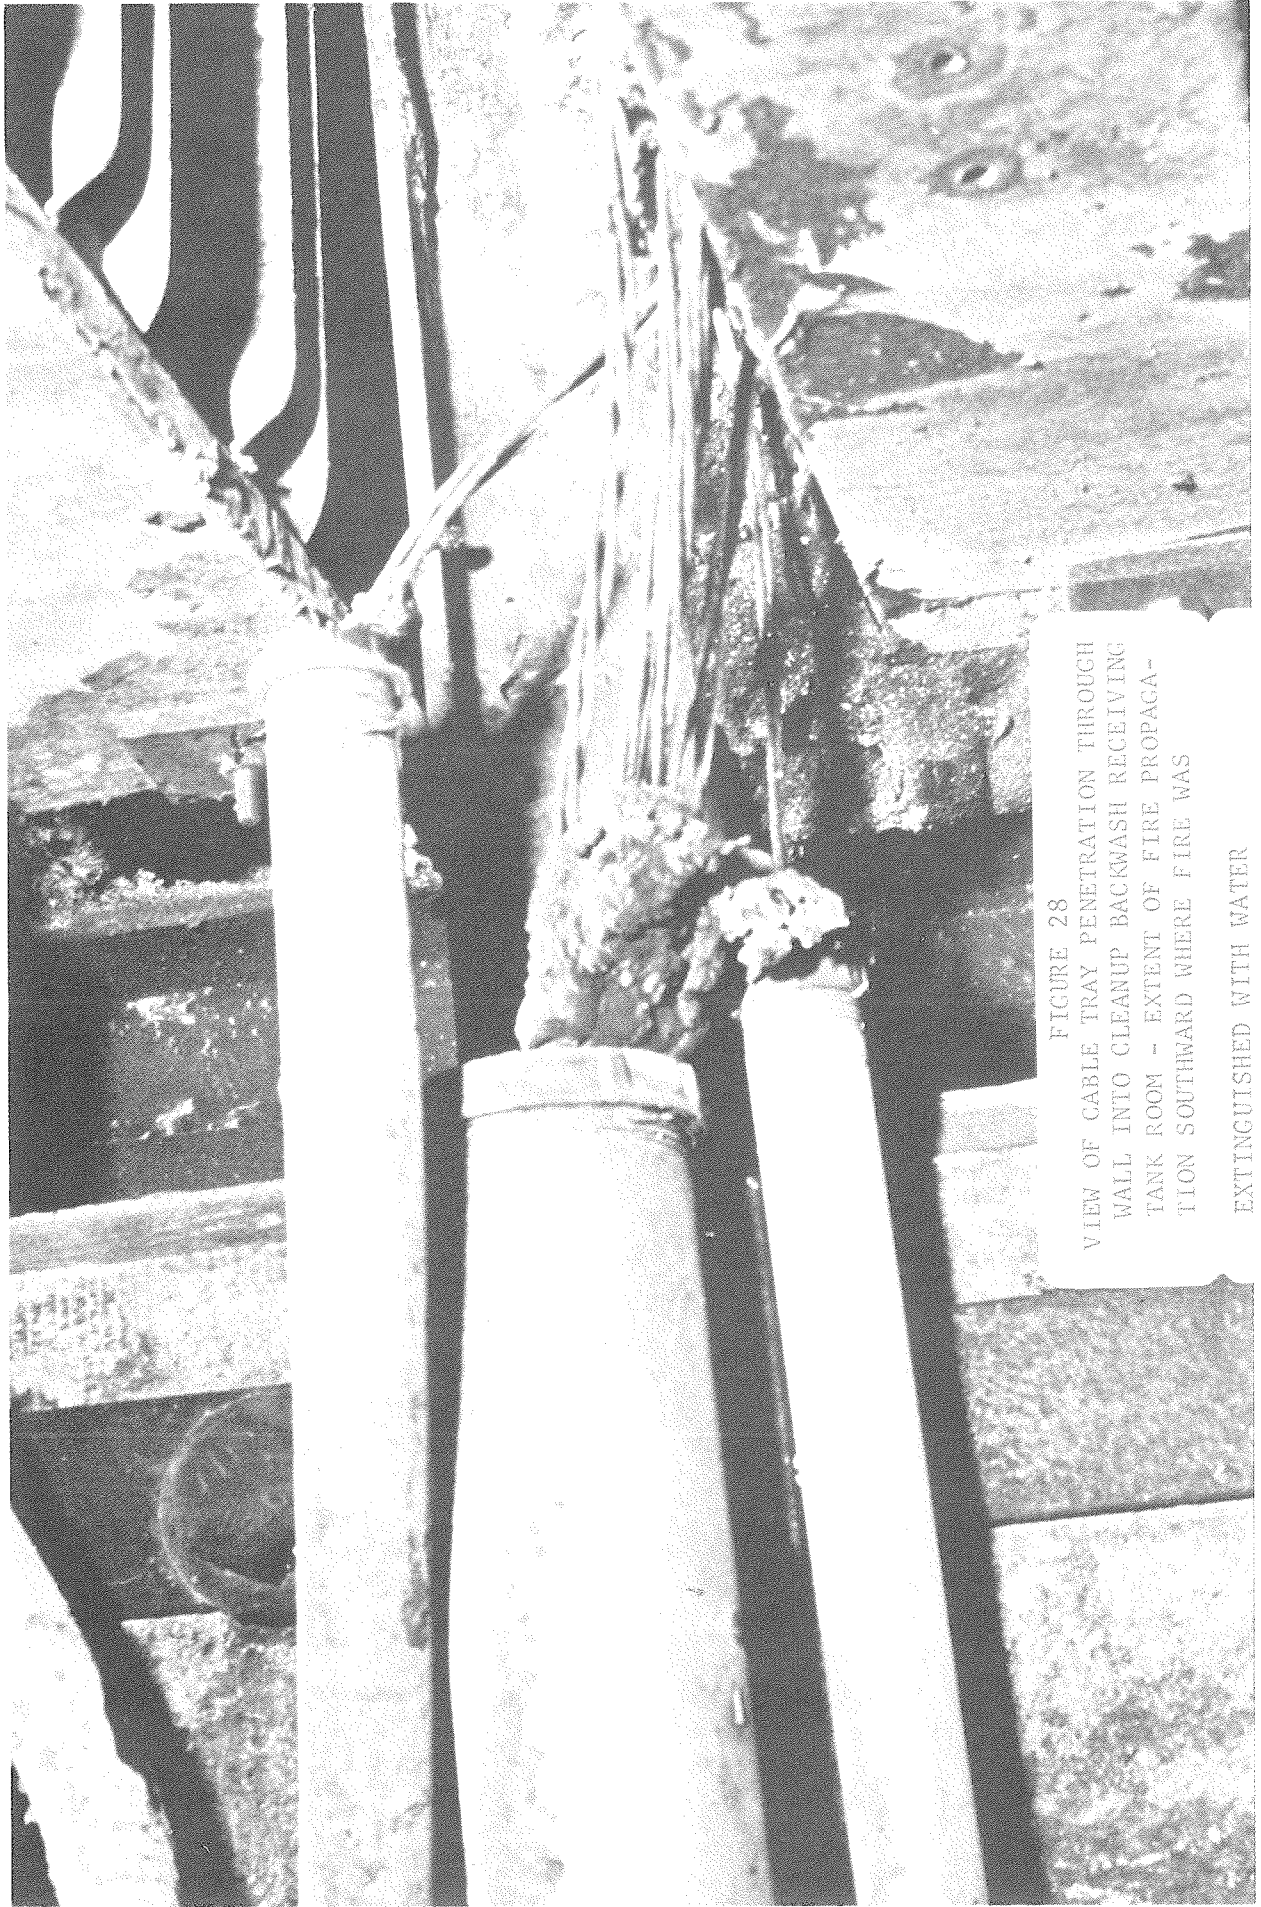
FIGURE 28

VIEW OF CABLE TRAY PENETRATION THROUGH
WALL INTO CLEANUP BACKWASH RECEIVING
TANK ROOM - EXTENT OF FIRE PROPAGA-
TION SOUTHWARD WHERE FIRE WAS

EXTINGUISHED WITH WATER

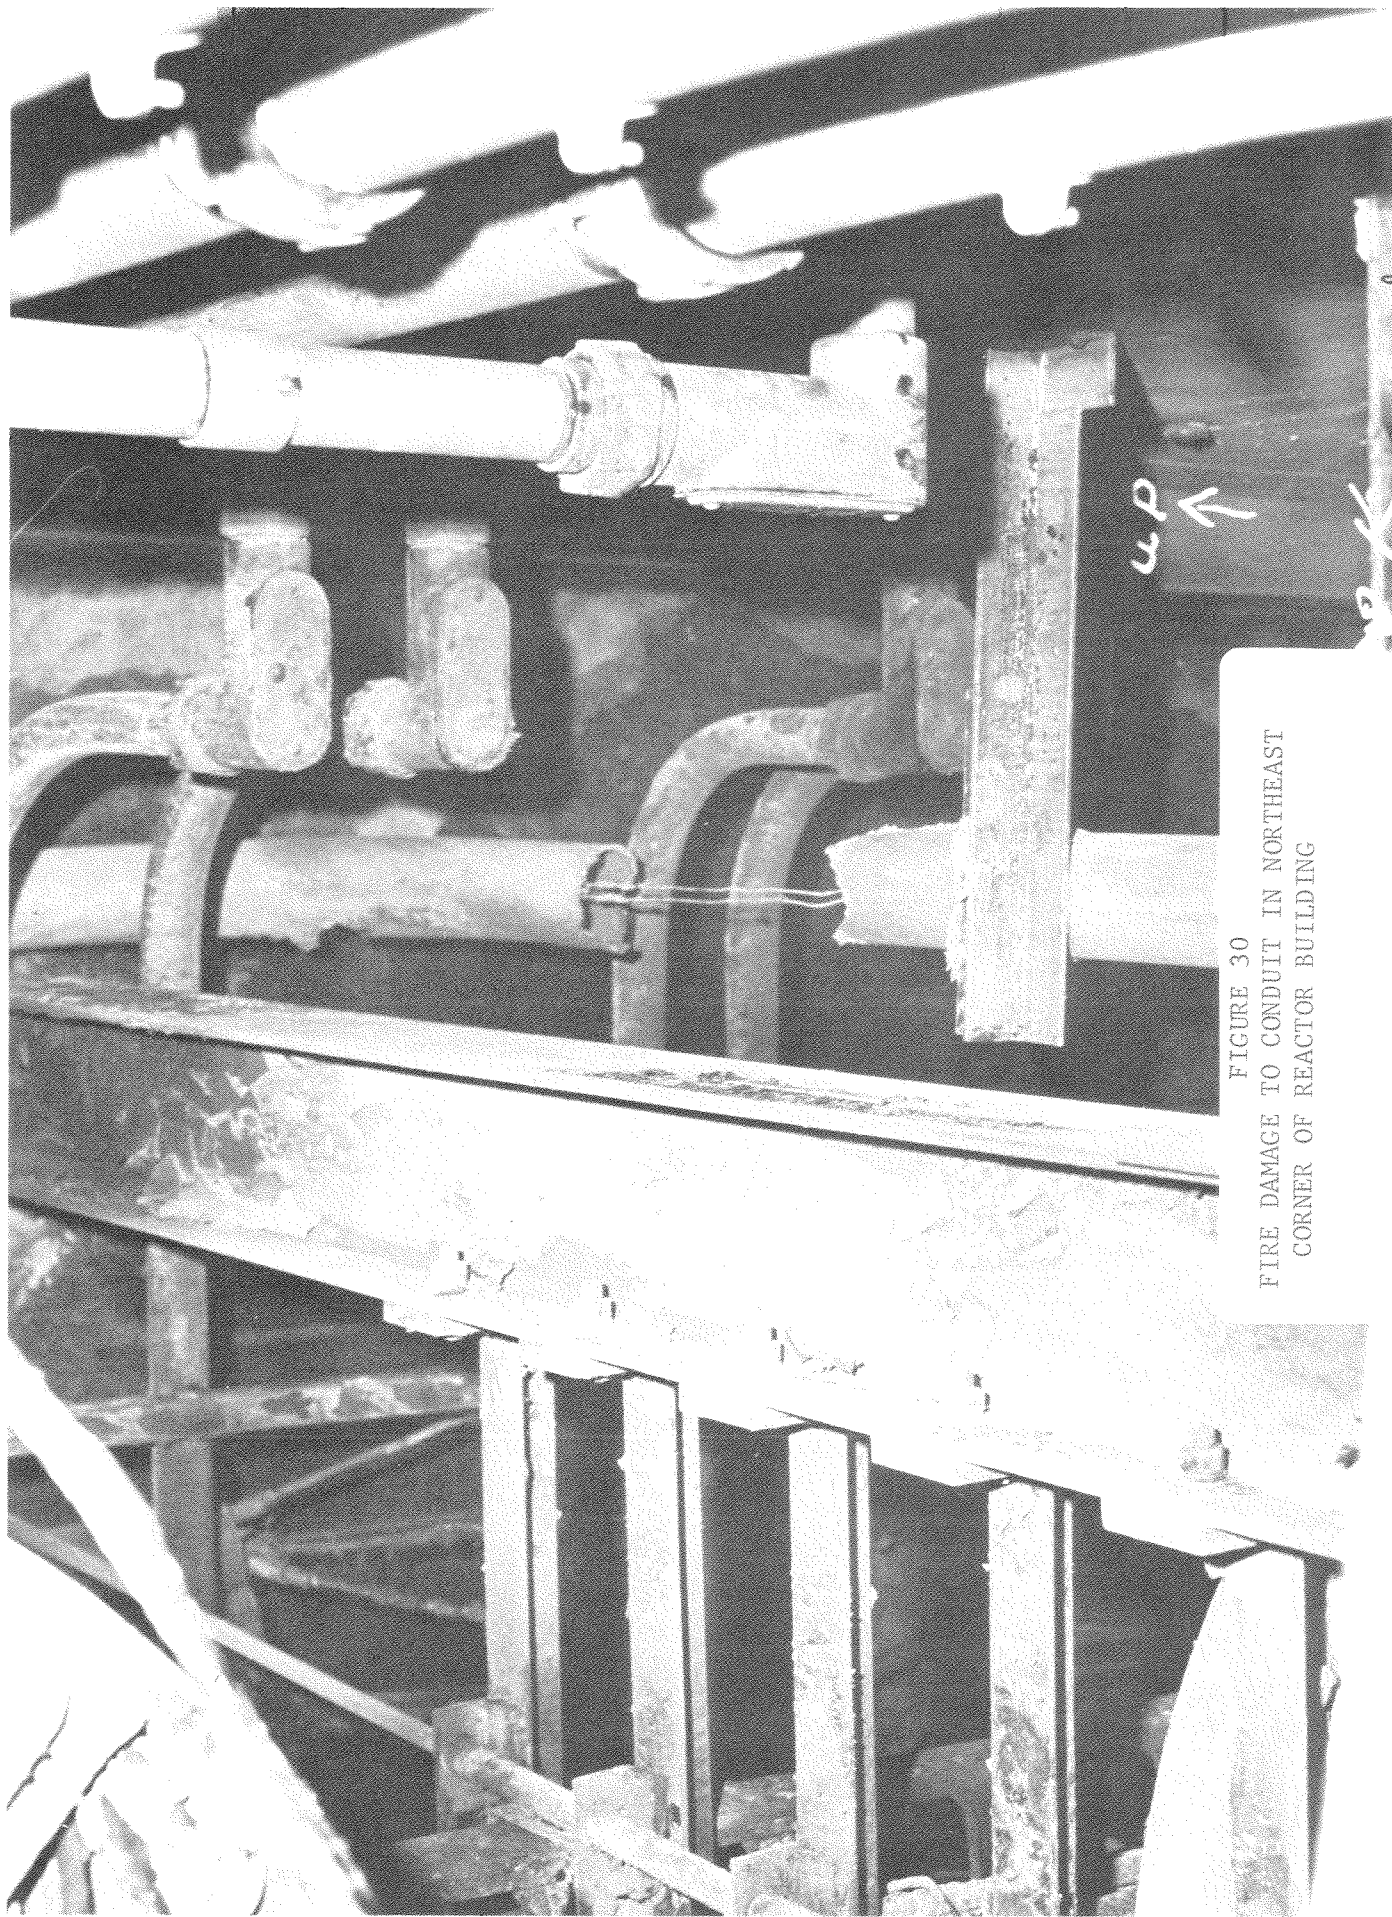
FIGURE 30
FIRE DAMAGE TO CONDUIT IN NORTHEAST
CORNER OF REACTOR BUILDING

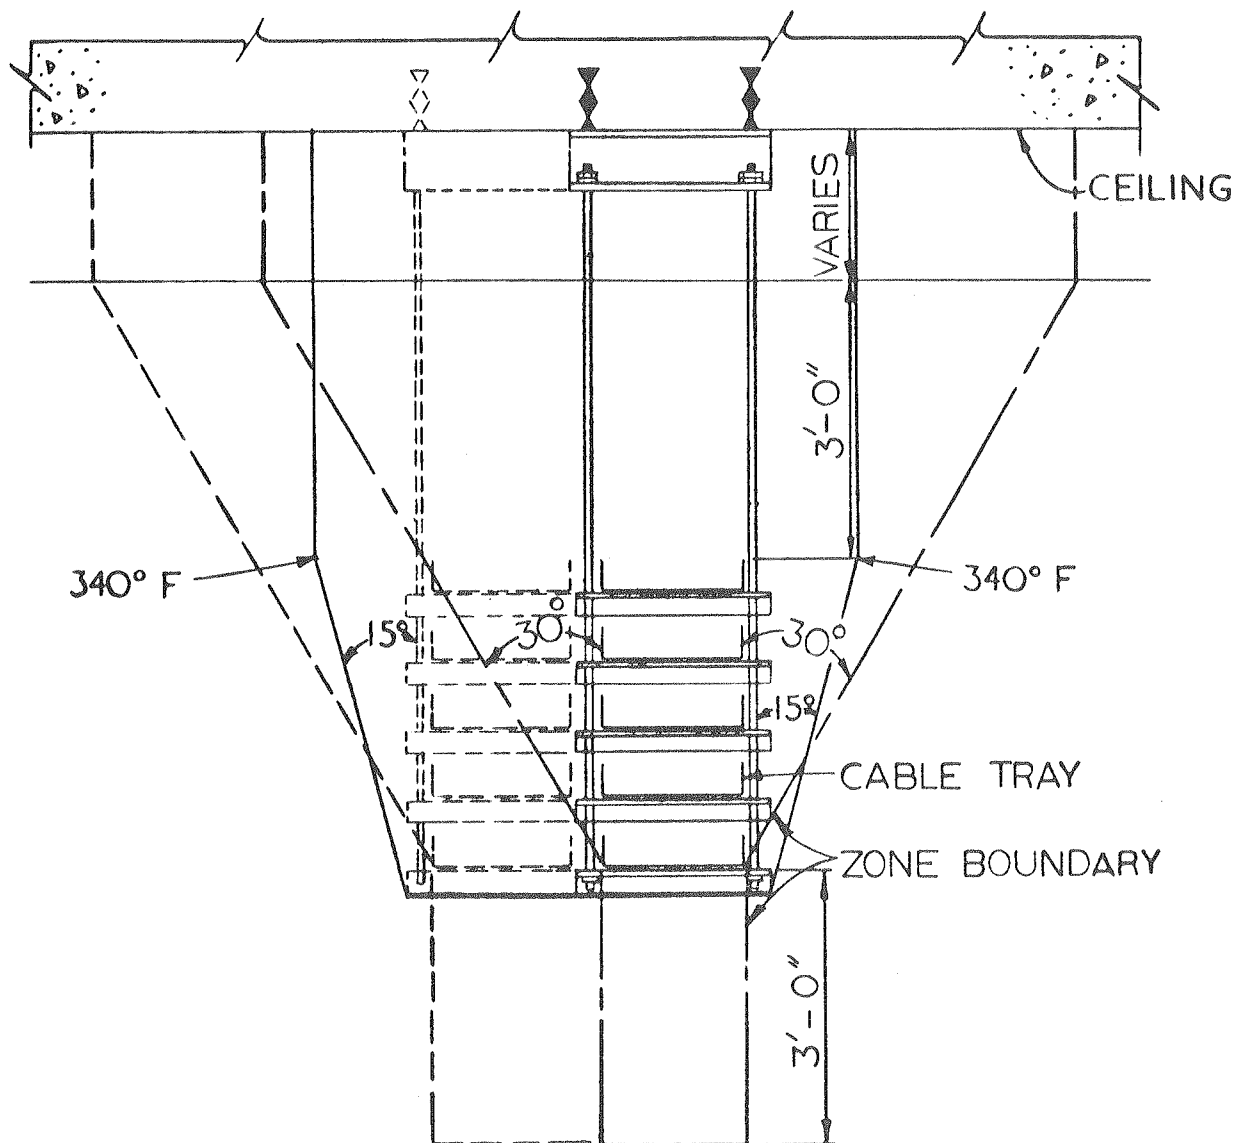
REGION 31
 REGION OF INFLUENCE OF FIRE IN CABLE
 TRAY
